Study of pathologies on flexible floors in the city of Teófilo Otoni, Minas Gerais

State, Brazil

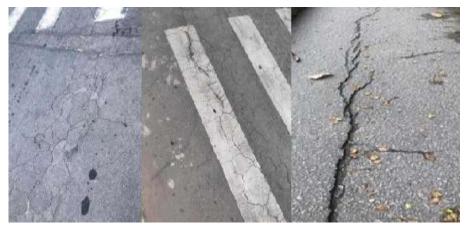
In the central region of the city, cracks were found interconnected mainly in the longitudinal direction, parallel to the vehicle traffic, as shown in Figure 4. The cracks are located near Sorveteria Chiquinhos, (in Rua Epaminondas Otoni, 766 - Centro, Teófilo Otoni - MG, 39800-013) and with reference to the Tristão da Cunha School (at Avenida Dr. Luís Boali Pôrto Salman, 1495 - Ipiranga, Teófilo Otoni - MG, 39801-000).

Figure 4. Longitudinal crack found in the central region of the city

The cause of the aforementioned pathology may be related to the contraction/expansion of the coating, poor execution of the longitudinal separation joint between the two traffic lanes, differential settlement, contraction of the asphalt layer, due to low temperatures, or the hardening of the asphalt. In this situation, palliative measures can solve the problem with the application of surface repairs, which can be done using a sealing layer to prevent water from entering and thus avoiding structural weakening (DNIT, 2010; Salomão et al., 2019).

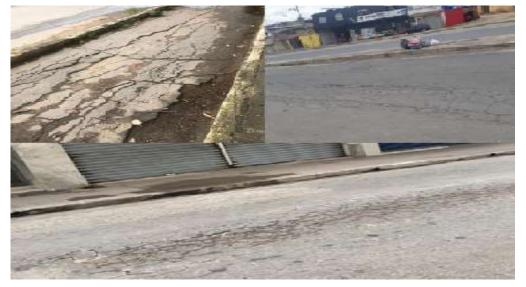
Cracks interconnected without preferential directions, as shown in figure 5, found in the central region, may be caused by the collapse of the asphalt coating due to the repetition of traffic actions, the undersized or the poor quality of the structure of one of the pavement layers. , the low support capacity of the soil, the aging of the pavement, or the asphalt being hard or brittle, therefore, the same techniques used in longitudinal cracks are recommended (DNIT, 2010; Salomão et al., 2019). To alleviate such causes, there are maintenance and restoration activities that are recommended by the DNIT Standard 154/2010 and are based on the improvement of drainage, replacement of sub-base, base and covering, resurfacing, or reconstruction of the application. It should be noted that the resurfacing and sealing layer, which works as superficial repairs, are efficient both for interlocking cracks of the block type and for the interconnected cracks of the alligator leather type, in this way, they have the same principle of repair for both pathologies (DNIT, 2010; Salomão et al., 2019).

Figure 5. Interlocking cracks without preferential directions

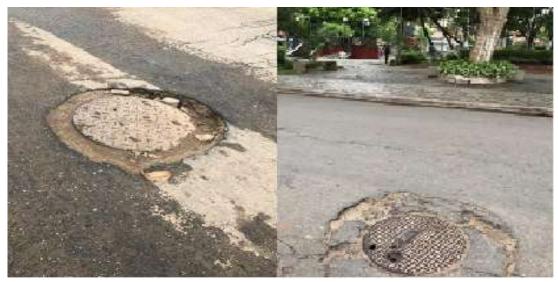
The pans or holes, as shown in Figure 06, were found in a few sections. The cause may be due to the overloading of vehicles by the axle. The recovery of this type of pathology can be accomplished through patches when well executed, however, this type of recovery is only recommended if the base, sub-base, and sub-grade has not yet been reached. If the hole is deeper, a straight cut should be made in the coating, then priming to seal the cracks and then applying a new asphalt pavement (DNIT, 2010; Salomão et al., 2019).

Figure 6. Pans or holes identified
