The throat of Brazilian Agricole production: The breakdown of vertical silos

Gargalo da produção agrícola brasileira: Colapsos de silos verticais

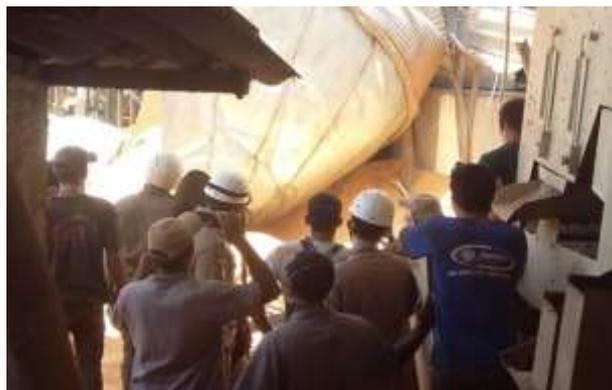
Figure 1. Silo in Tangará da Serra- MT.

On November 25, 2016, two metal silos with a capacity to store 5,000 bags of corn each, collapsed in Tangará da Serra - MT, leaving a fatal victim (Figure 1). The worker was cleaning the place when the structure collapsed, according to reports, in an attempt to escape the first collapse the victim was surprised by the fall of the second silo.

In addition to the Fire Department, company employees helped to rescue the worker (Figure 1). It can be seen from Figure 1 that the structural failure in the first silo caused the spread of the damage in a chain reaction, resulting in the collapse of the entire structure, and culminating in the loss of a life.

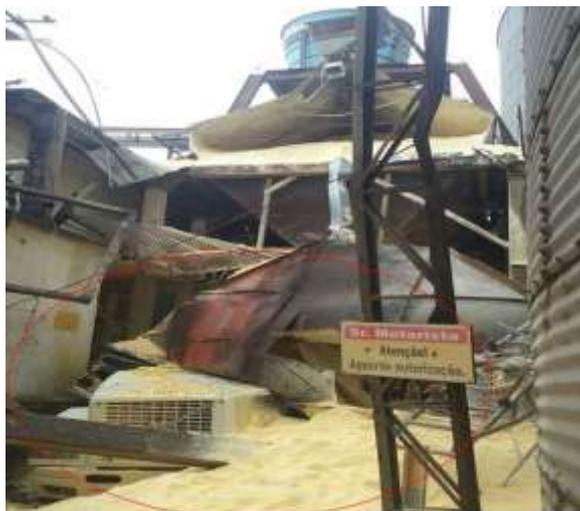
Figure 2. Silo storing wheat bran in Faxinal - PR.

On April 6, 2017, a metallic silo that stored wheat bran in Faxinal - PR collapsed on top of the truck (Figure 2), there was an employee inside the vehicle that was buried.

Figure 2 shows the wreckage of the structure and the product above truck, as shown by the red circle. the breakage of the structure may have been caused by the collapse of the vault, due to the stored powder cohesive properties. according to Cheung et al. (2015) a large number of silos have deformations at its bottom and sides due to the collapse of vaults from cohesive products.

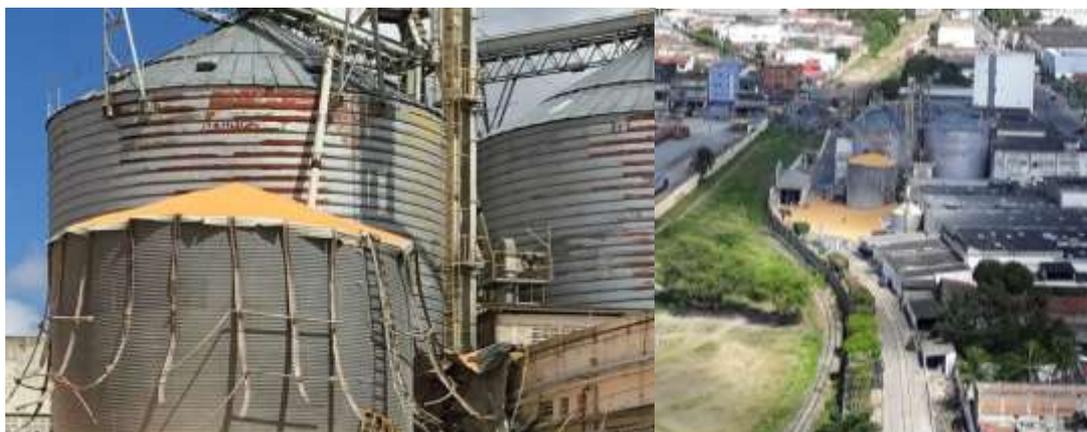
Figure 3. Silo breakdown in Campina Grande - PB.

On August 8, 2018, a silo that stored corn in a factory located in the city of Campina Grande - PB, broke down and buried an employee (Figure 3).

The image on the left (Figure 3) shows the silo after the collapse, with part of the granular product still inside, and the right side, the aerial image of the product spread across the factory yard after the accident.

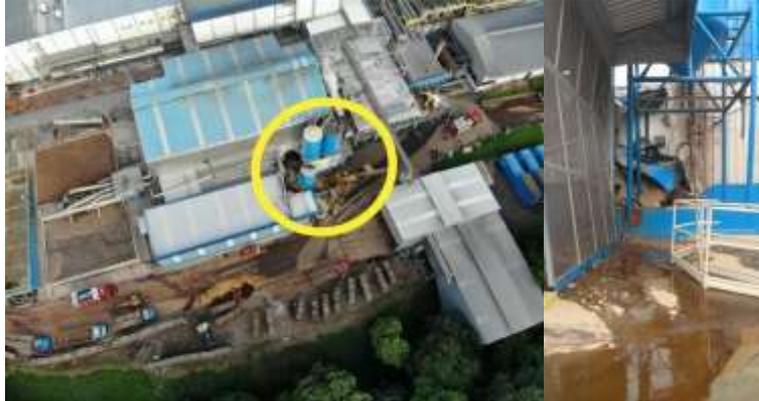
Figure 4. Accident with a fatal victim in Passo Fundo - RS.

On November 18, 2019, in Passo Fundo-RS, as determined by the Civil Police, an employee carried out the loading of a feather meal silo - used for animal feed - manually through a hatch. The estimate is that there were, at that time, 40 tons of the product, for a capacity of 50. People who were at the site reported that an explosion followed by a flash in the silo. Then the entire structure collapsed, including the platform on which the victim was.

The yellow circle shows the placement of the broken silo on the factory premises (Figure 4). The image on the right side allows a frontal view of the debris after a possible explosion (Figure 4). Lopes Neto & Nascimento (2018) state that explosions are one of the most common causes of accidents involving these structures. Calil (1982) states that the fine particles of many stored materials can form clouds of explosive dust when suspended in the air, whereas, if ignition occurs, the heat produced by the combustion of the particles of the powdery material, sometimes combined with the reaction of gaseous products, can cause a rapid increase in the pressure of the structure and result in an explosion of the silo, measures must be taken against the danger of dust explosions (apart of ignition sources, control with welding works, etc.).

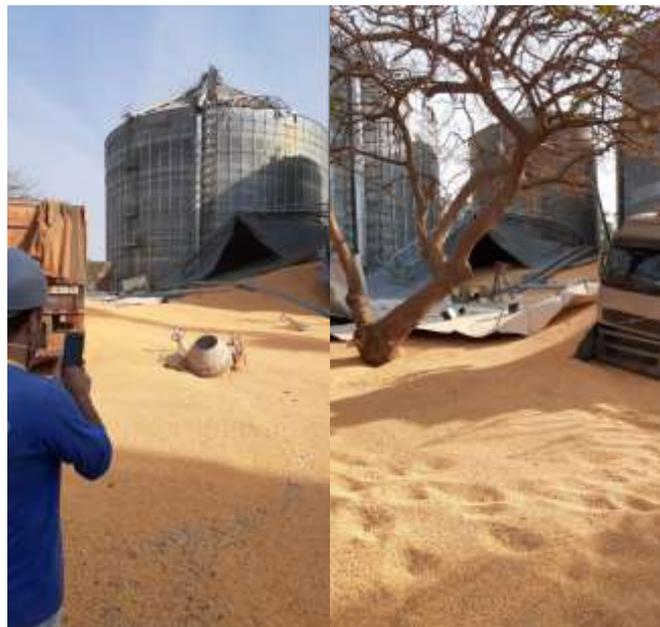
Figure 5. Debris from the silo that broke in MT.

On August 15, 2020, a silo loaded with corn kernels broke and spread the entire load in the courtyard of a private company, with no fatalities (Figure 5). The incident happened in the Eldorado District, which belongs to the municipality of Tapurah - MT.

The structure after the collapse is shown by different angles in Figure 5, the wreckage indicates a structural deficiency in the stiffeners and side plates.

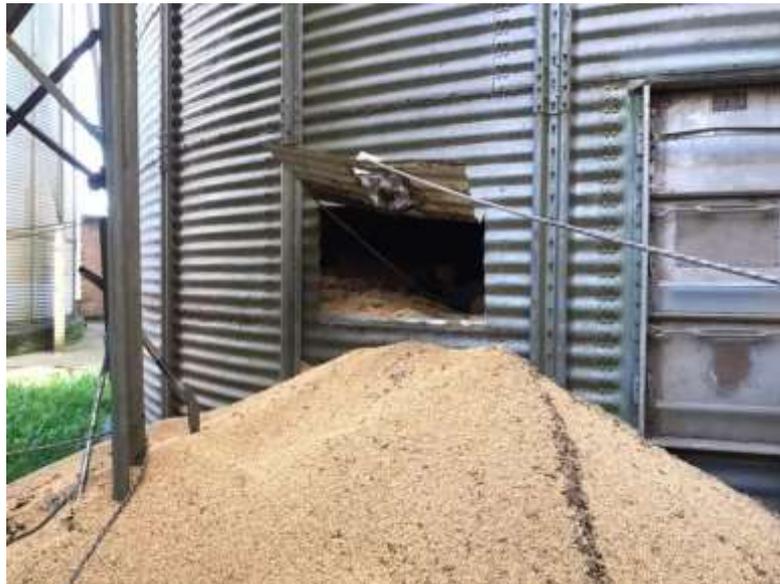
Figure 6. Detail of the opening at the bottom of the structure for removing soybeans and rescuing the victim.

On January 10, 2021, another fatal victim was registered in a silo accident in Brazil. In the city of Ypê - RS, according to a record from the Fire Department, an employee was inside a silo that stored soybeans, breaking clods of grain that accumulated and did not pass through the grain elevator. The boy ended up falling into an air pocket and being buried by the product (Figure 6).

The cut made by the Fire Department at the bottom of the structure in order to empty the silo and remove the victim is shown in Figure 6. Cheung et al. (2015) state that soybean consolidation occurs due to the formation of cohesive mechanisms, possibly arising from the high moisture level (above the upper limit defined in the project).
