Sampling selection methodology: inventoried façades of Pelotas/RS

Metodologia de seleção para amostragem: fachadas inventariadas de Pelotas/RS

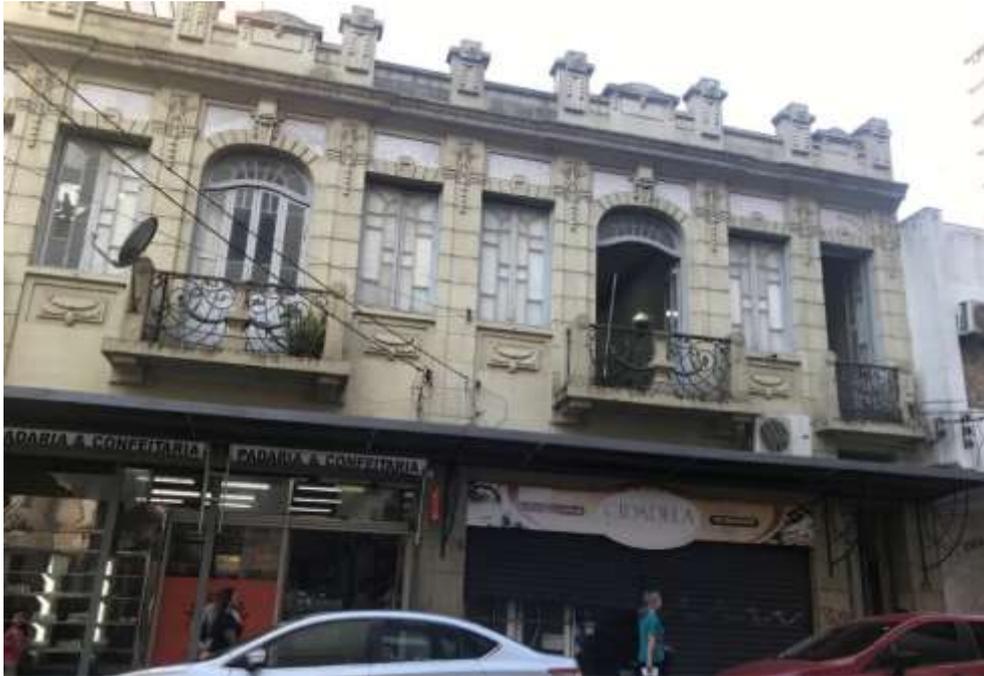
Figure 3: Facade of Block 1.8 - Street XV Novembro, 664.

Field surveys were carried out during the morning shifts (09:00 - 12:00) and the afternoon shift (14:00 - 18:00). The aiming of this stage was recognizing the samples and cataloguing them by photos. The photos were taken in a perpendicular plane of the facade (90°). In view of the difficulty of making photos without distortions, since the city center has several streets with small dimensions and with the presence of cars and vegetation, some photos were made with misrepresented in the angulation according to Figure 3.

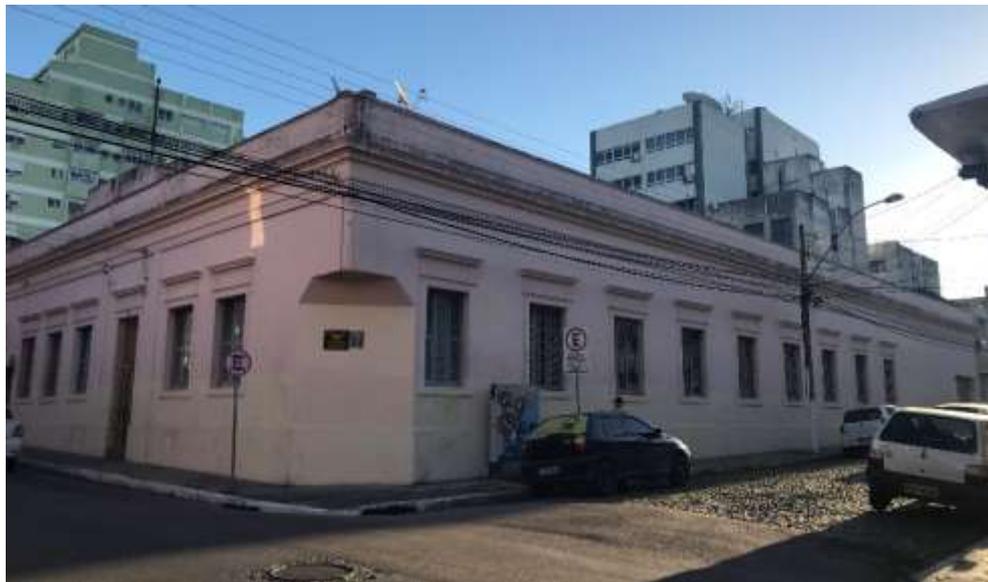
Figure 6: 2 Facade of Block 2.10 Street Félix da Cunha, 821.

In addition to the number of floors, buildings with large dimensions of facades was eliminated. According to the Figure 6, a photographic montage to obtain all the facades would be necessary. At this stage, a pre-selection of 279 properties was reached.

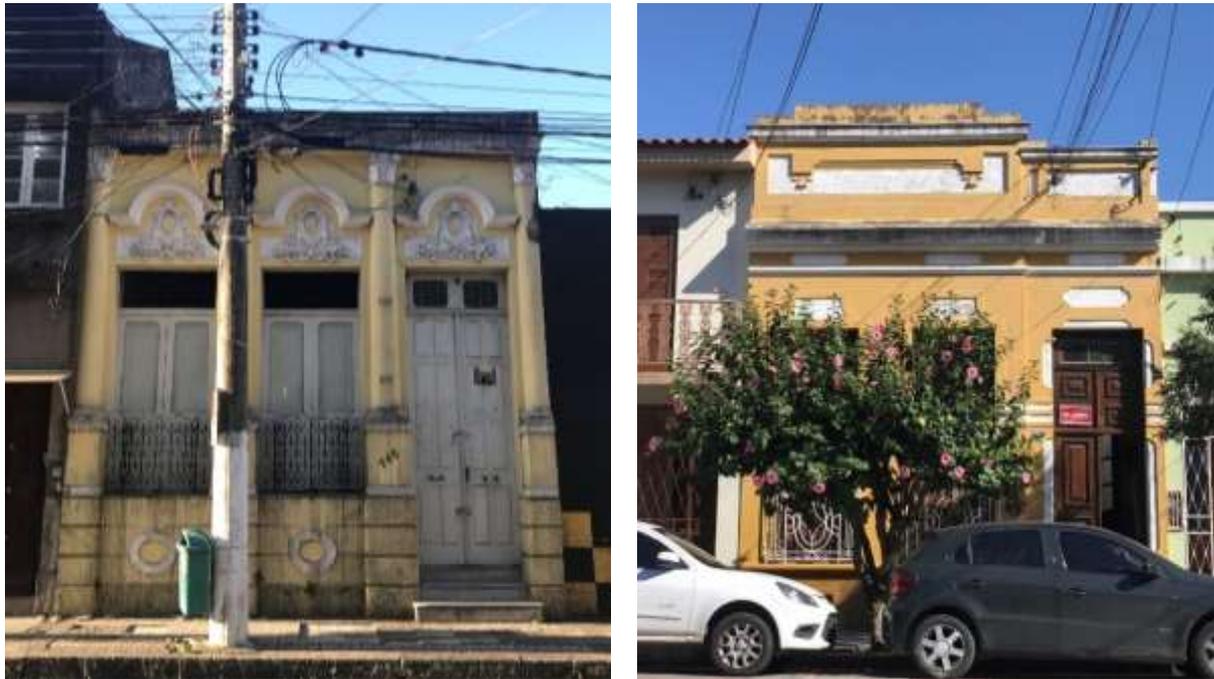
Figure 7: 3Facade of Block 2.9 Street Voluntários da Pátria, 746 and Facade of Block 3.2 Street Santos Dumont, 335.

Buildings with physical barriers, as trees, poles, and bus stops in front of the facades, as can be seen in Figure 7, were excluded. A pre-selection of 203 properties was reached.

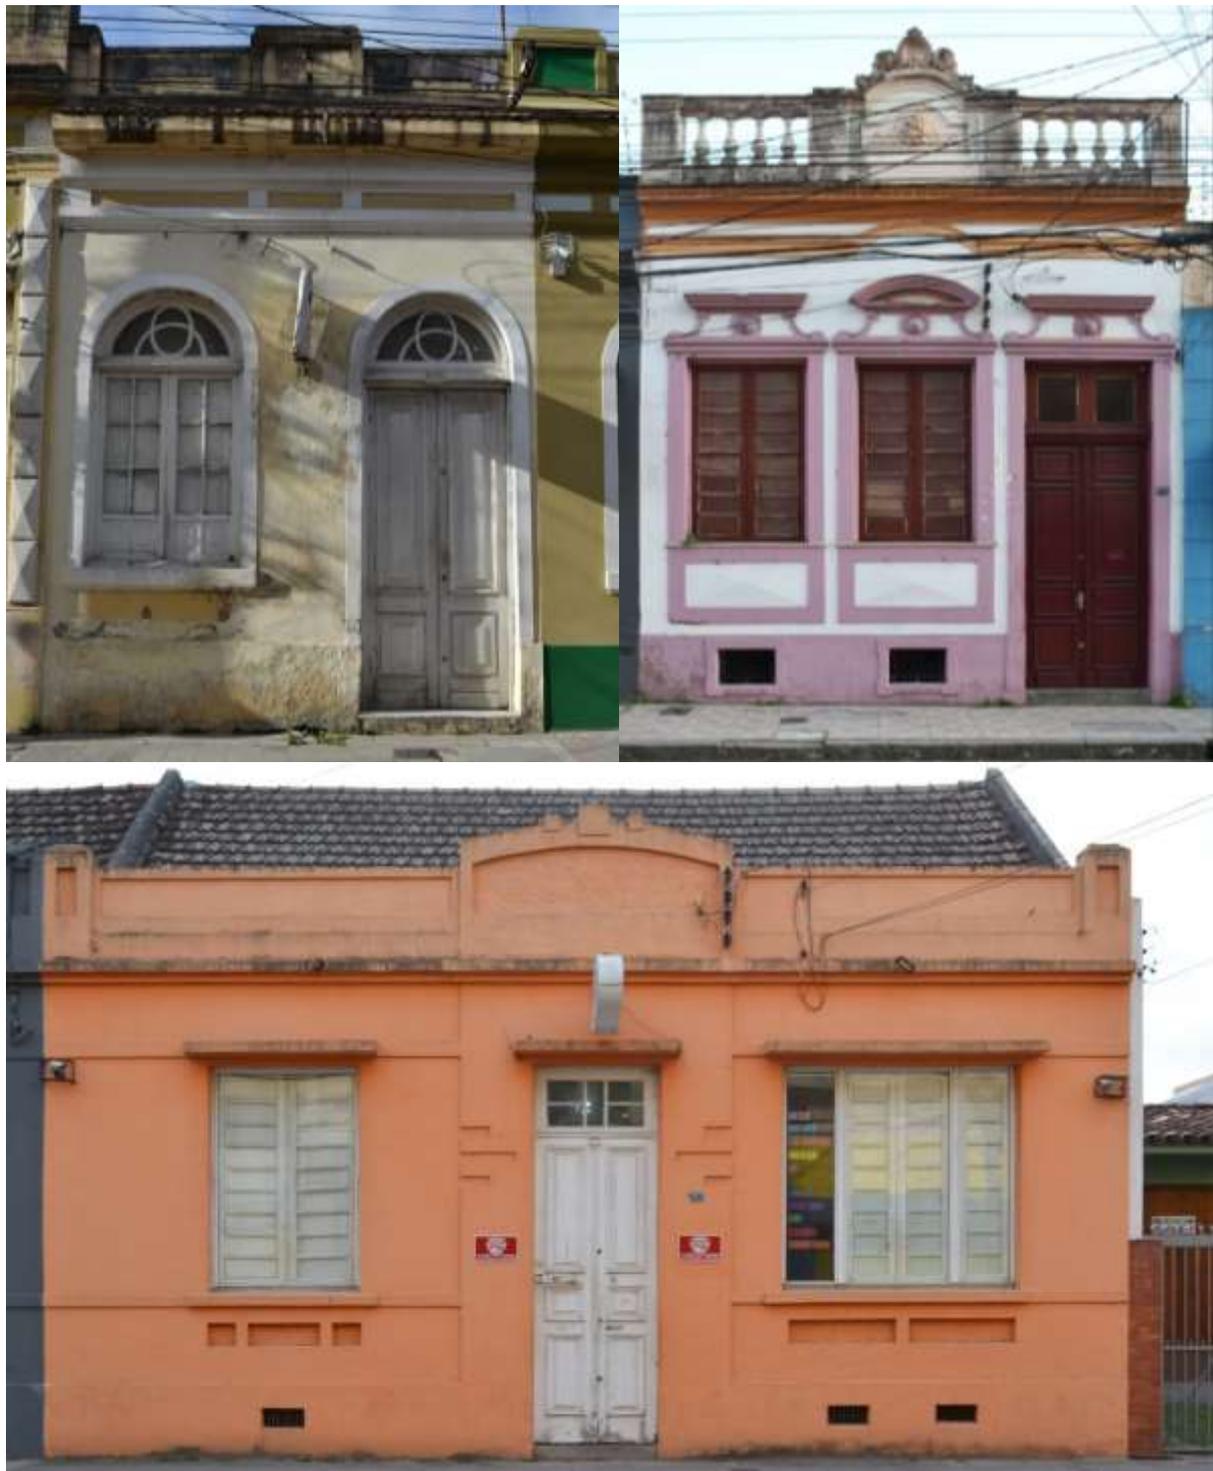
Figure 13: Pelotense architecture: side corridor house, door and window house and central corridor house.

Three facades with type of door and window facades, side corridor and central corridor are presented in Figure 13. All of them are exemplary of Pelotas architecture.

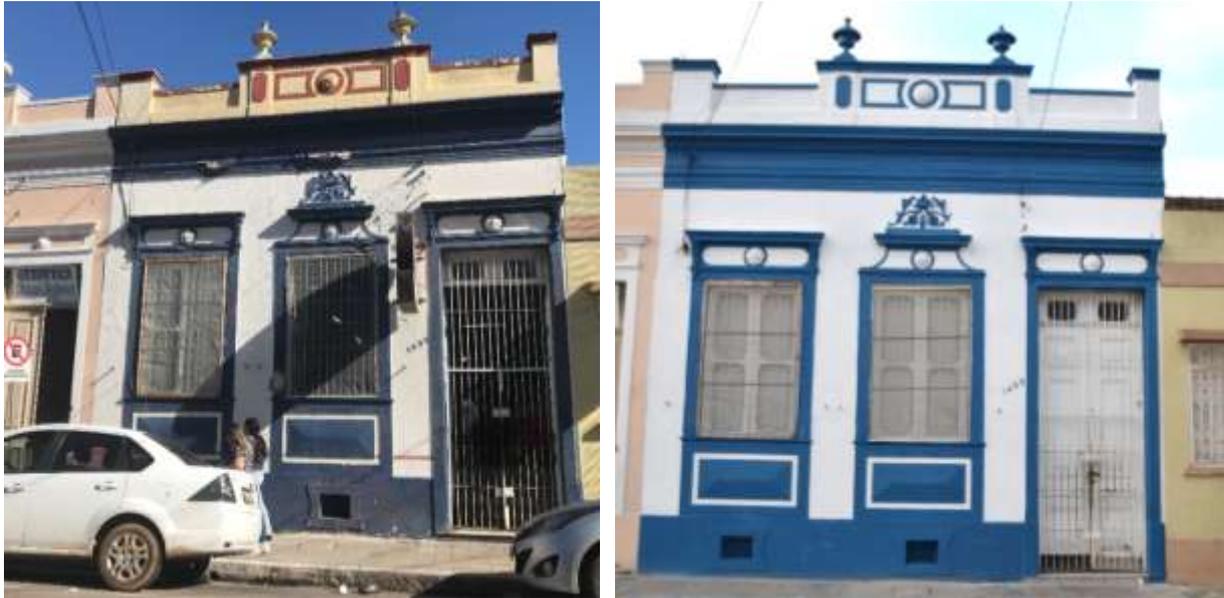
Figure 14: Preliminary survey of the facade - Block 1.3 Street Voluntários da Pátria, 1405
versus final survey of the facade - Block 1.3 Street Voluntários da Pátria, 1405.

In view of the difficulties faced in the preliminary survey with the presence of cars and pedestrians, the field surveys were carried out in the morning shift (06:00 - 09:00). Times and days with less people circulation were selected, making photographs without physical barriers possible. As described in the previous step, the photographs were taken perpendicular to the facade plane. Between preliminary survey stage and the final survey of the facades, some buildings underwent conservation interventions, such as paintings and renovation, as shown in Figure 14, were excluded.
