Implementation of an innovative strategy to control scorpions in the Serra Negra, state of São Paulo, Brazil

The municipal cemetery occupies an area of 25,627 m² (Figure 1). It is in the center of the city of Serra Negra. After responding to a scorpion accident at a residence located in an urban area, the resident was advised to test the installation of an inverted PVC gutter on the outside of his wall, in an attempt to prevent the animal from entering the property. The results obtained were satisfactory, which raised the idea of placing them throughout the entire cemetery to stop the invasion of this arachnid into the surrounding homes.

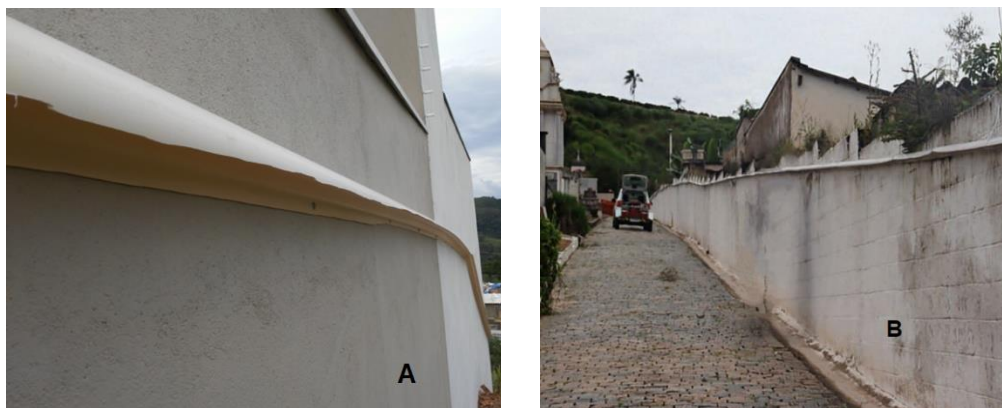
PVC pipes measuring 100 mm (4 inches) and a 6-meter bar were purchased. The pipe was divided in half, yielding 12 meters of gutter. The installation was carried out on an internal wall, 1.80 meters above the ground (Figure 2). The gutters were installed by a company hired for this purpose, inverted, and fixed to the wall with plugs and screws. Screws and plugs were fixed every 20 centimeters to secure the gutter and provide greater support to the structure. As the cemetery wall has uneven surfaces, expanding foam was used to seal openings in some spaces. The gutter joints were designed to prevent grooves or mechanisms that would allow it to be passed through. After installing the gutters, chemical control measures for cockroaches were implemented in the municipal cemetery.

Figure 2 – Inverted PVC pipe structure installed around the municipal cemetery. (A) wall of property with installation of the device; (B) installation on the inside of the cemetery wall that borders houses. Municipal Cemetery of Serra Negra, state of São Paulo, 2024.

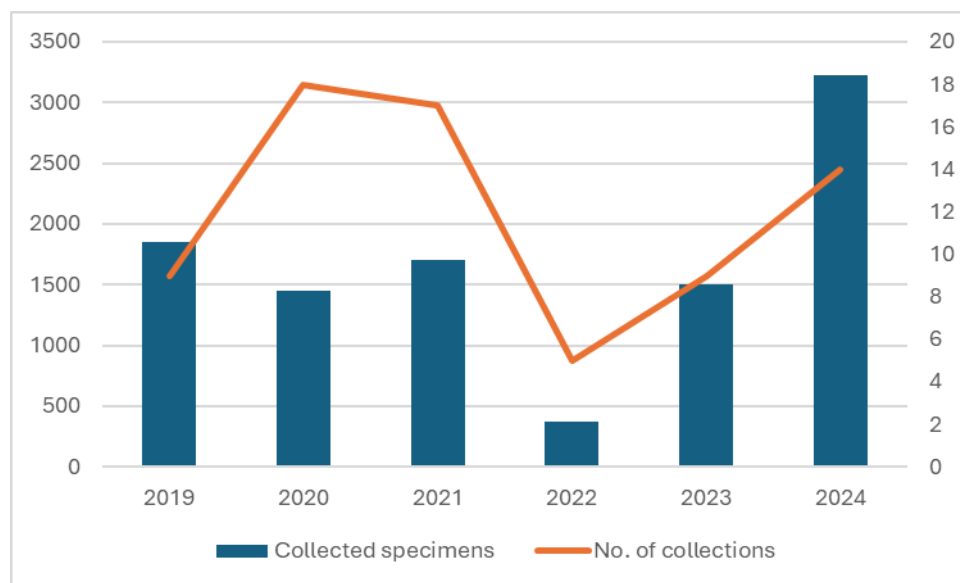
When analyzing the municipality of Serra Negra, an increase in the number of scorpion specimens collected in cemeteries was observed between 2023 and 2024 (Figure 3). The year 2022 was the one in which the lowest capture rate was recorded, reflecting the impact of the COVID-19 pandemic.

Figure 3 – Scorpion specimens collected in the cemetery of Serra Negra, Brazil, from 2019 to 2024.
